This spreadsheet performs screening level calculations to estimate the effect of peeling leaded paint on the average concentration of lead in yard soil
1828 36th Avenue

Property ID: 390	Date: 8-18-05
Address: 1828 36TH AVE	Telephone #:
Owner:	CO Certification #: 12860
Inspector/Assessor:

LBP Assessments Results

SITE NAME: VASQUEZ BOULEVARD AND I-70

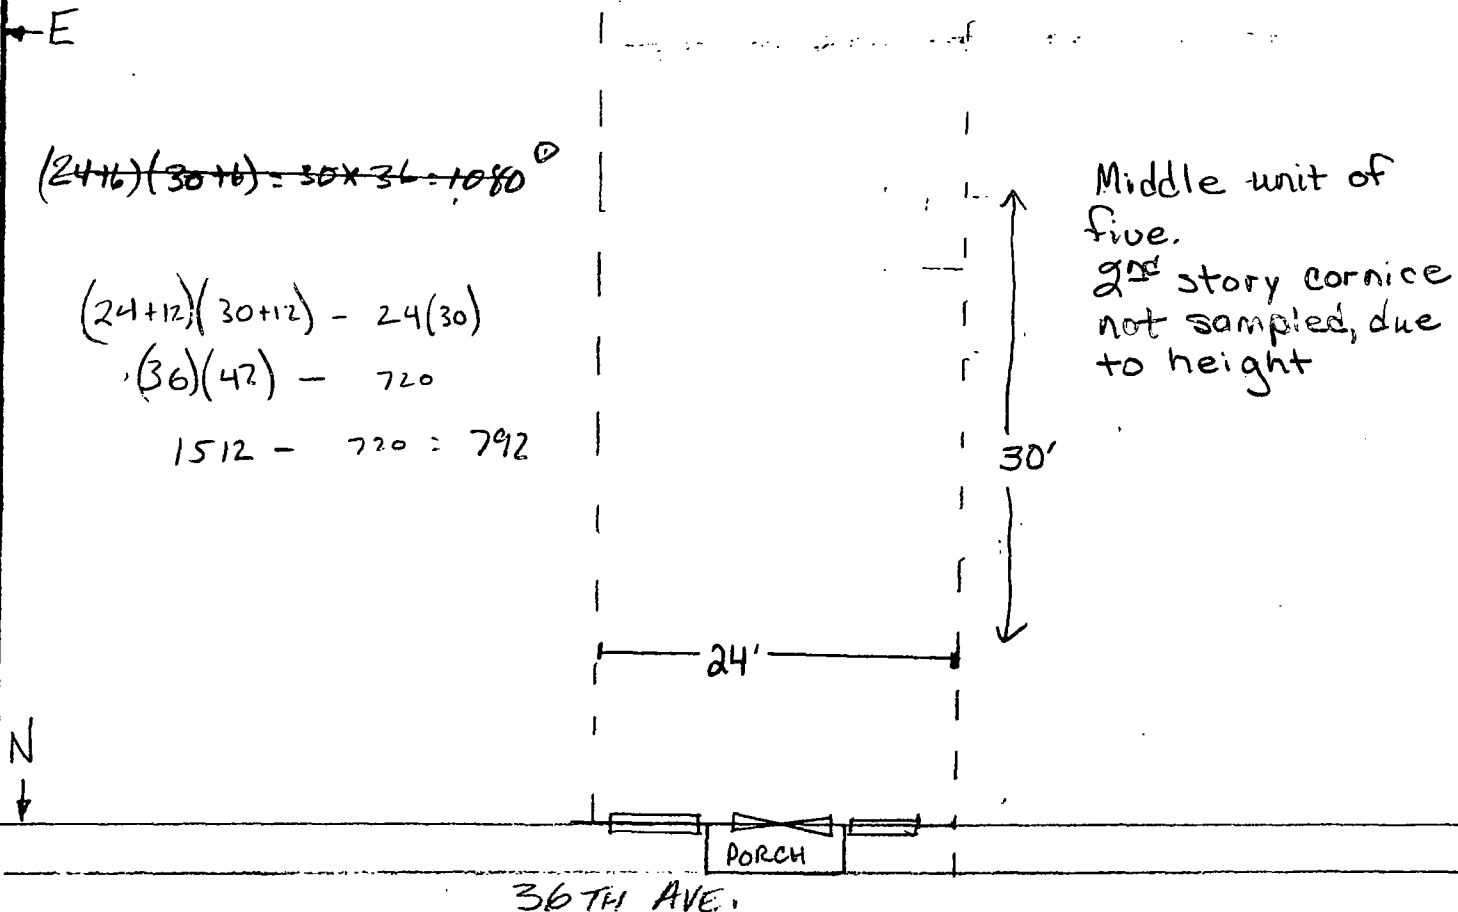
Plot Plan:

North South East West	Exterior Walls				Doors/Trim			
	Material	Area	Peel/Chip	XRF (Lead)	Material	Area	Peel/Chip	XRF (Lead)
					WOOD	18'4"	PEEL	5.0
North South East West	Window Trim/Escia/Soffit				Patios/Decks/Porches			
	Material	Area	Peel/Chip	XRF (Lead)	Material	Area	Peel/Chip	XRF (Lead)
	WOOD	28'4"	PEEL	6.2	WOOD	40'4"	PEEL	5.
North South East West	Metal Trim/Gutters/Downspouts				Misc Structures/Garage/Fences			
	Material	Area	Peel/Chip	XRF (Lead)	Material	Area	Peel/Chip	XRF (Lead)
